# Case Study of an Electric Vehicle Battery Thermal Runaway and Online Internal Short-Circuit Detection

*Abstract*—A thermal runaway happened in a battery cell of an electric vehicle during driving, and the fire spreads to other batteries in a few minutes. Based on the recorded battery operation data, this letter analyzes the battery thermal runaway process, and identifies the critical time points of fault signals like cell voltages and temperatures, etc., which depict the start and spread of thermal runaway in the battery pack. By tracing back the clues, it is concluded that the cause of the fire is battery internal short circuit (ISC), and battery overcharge is a potential cause of ISC. Then, three different patterns of battery cell voltage abnormalities are compared, including battery external short circuit, ISC, and poor-signal wire connection. A cell voltage difference-based method is proposed to diagnose ISC online, which is simple and reliable to implement in engineering.

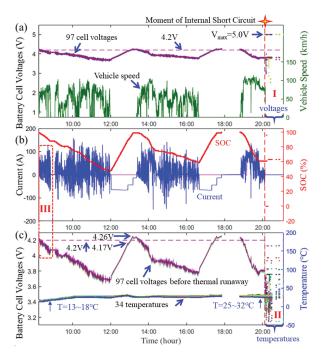
Fig. 1 shows the vehicle operation data of the day when TR happened. The vehicle started to operate from about 8:00 A.M. and operated normally during the day until TR occurred at 20:07:13 P.M. The battery temperatures were

Fig. 1. EV operation data of the day. (a) Cell voltages and vehicle speed. (b) Current and state-of-charge (SOC). (c) Cell voltages and temperatures.

between 13 °C and 32 °C, and the maximum charging/discharging currents were below 1 C-rate. The vehicle was driven more than 400 km during the day. The odometer reading was about 10 000 km, which suggests the vehicle was fairly new.

Fig. 1(c) shows that each charging process consists of three stages: 65 A charging to 4.17 V, then 44.7 A, and 13.5 A charging to 4.26 V, respectively. For most LiNMC traction batteries, the charging cutoff voltage is set to 4.2 V, and many OEMs are trying to avoid fully charging the batteries to ensure safety and prolong battery cycle life. However, the OEM of this EV is trying to overcharge the batteries to achieve a longer driving range. According to Table I, approximately 10% more energy (6 kWh) was charged to the batteries in stages 2 and 3, which could extend the EV driving range by 44 km (13.5 kWh/100 km). Area III in Fig. 1(b) also shows that this EV allows braking energy recovery

Although we cannot draw a concrete conclusion that overcharge is the cause of this TR accident, it is still highly recommended not to overcharge the batteries.

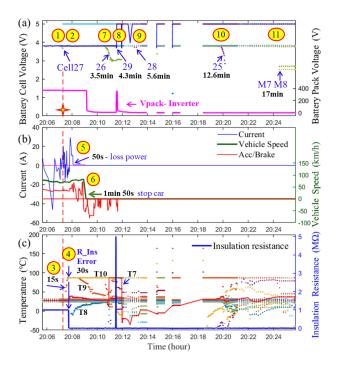
After TR started at 20:07:13 P.M., many signals began to show fault readings, as depicted in regions I and II of Fig. 1. A zoomed-in figure after TR is shown in Fig. 2. The battery cell voltages scattered between 2 and 5 V. Some batteries experienced continuous voltage drop, including cell 27, 26, and 25, as illustrated in Fig. 3(a)–(c).

Temperatures in Fig. 2(c) scattered between -40 and 85 °C, which is the limit of temperature readings in the BMS. Negative temperature coefficient (NTC) sensors are usually used to measure temperatures. High sensor resistance indicates low temperature. When the NTC signal wires got burned in the fire during the accident, the resistance of the signal wires would increase dramatically, thus inducing low-temperature readings in the BMS. After the fire went out, temperature readings would recover gradually. Therefore, subzero temperature readings can be used as evidences of fire in the battery pack.

Fig. 2. Battery TR and its propagation. (a) Battery cell voltages and battery pack voltage. (b) Current and vehicle speed. (c) Temperatures and insulation resistance.

*Step 6:* 20:09:03 (1 min 50 s): The vehicle speed was about 61 km/h, then the driver stopped the car, and the dc bus voltage of the inverter was disconnected. However, the Acc/Brake pedal signal in Fig. 2(b) shows that the driver did not evacuate immediately but tried to restart the vehicle 2 min later on Step 8.

In this approach, ISC could be identified even before a high temperature is detected. Thus, the warning could be advanced by at least 15 s, i.e., from Step 3 to Step 2 in Fig. 2. False alarms could also be avoided by considering different voltage failure modes. The simplicity and reliability of the method make it promising for engineering applications.

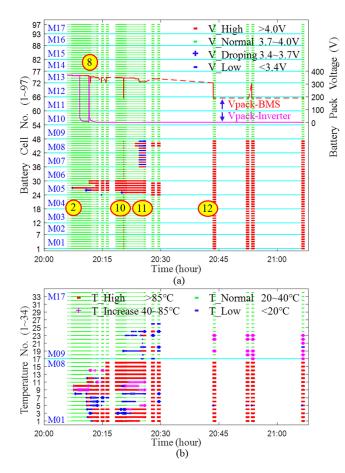
Fig. 4 shows the battery cell voltage and temperature fault signals propagation in the battery pack. The gaps in the signals suggest that the BMS was waken up nine times after TR.

Fig. 4. Battery cell voltage and temperature fault signals propagation map. (a) Battery cell voltage error propagation (b) Temperature error Propagation.

*Step 10:* 20:19:53 (12.6 min): TR occurred in battery cell 25, as depicted in Fig. 3(c). Then, the explosion caused the battery measurement unit (BMU) to restart, thus V1–V47 signals were offline for a few seconds, as shown in Fig. 4(a).

*Step 11:* 20:23:09 (17 min): Battery voltage signal errors of V36–V47 (M07 and M08) were detected. But the pattern seems like signal wire or BMS failure but not a TR.

*Step 12:* 20:43:29 (37 min) to 21:06:00 (1 h): In M01–M08, all signals (V1–V47 and T1–T14) were offline. This suggests the BMU was damaged in the fire. It is not clear whether TR spread to other submodules besides M05. In M09–M17, all battery cell voltages were normal, suggesting TR was not spread to these submodules. However, there were still high temperatures detected in M09–M11.

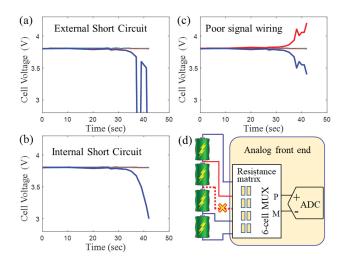
Fig. 5. Different patterns of battery cell voltage fault signals. (a) Battery external short circuit. (b) Battery ISC. (c) Poor voltage signal wire connection. (d) Voltage measurement and poor signal wiring.

Fig. 5 compares three different battery voltage fault signal patterns. When an external short circuit occurs, the battery voltage would drop dramatically to nearly zero, and may jump back and forth. In the case of ISC, there would be a continuous voltage drop process. Poor voltage signal wiring is usually caused by a loose connector. In this case, usually the two adjacent voltage readings would diverge to opposite directions, because the poor contacted voltage signal is floating while the upper voltage channel loses ground reference, as depicted in Fig. 5(c) and (d). Therefore, the continuous voltage drop is a unique feature of battery ISC, and this feature can be used to detect ISC online.
